# Inspection Report

**Mr. John Q Homeowner**

**Property Address:**  
1 Hometown Lane  
Hometown VT

<b>Date:</b> 11/20/2006	<b>Time:</b> 10:00:00 AM	<b>Report ID:</b> 11200601
<b>Property:</b> 1 Hometown Lane Hometown VT	<b>Customer:</b> Mr. John Q Homeowner	<b>Real Estate Professional:</b> Betty Homeseller Homes-R-Use

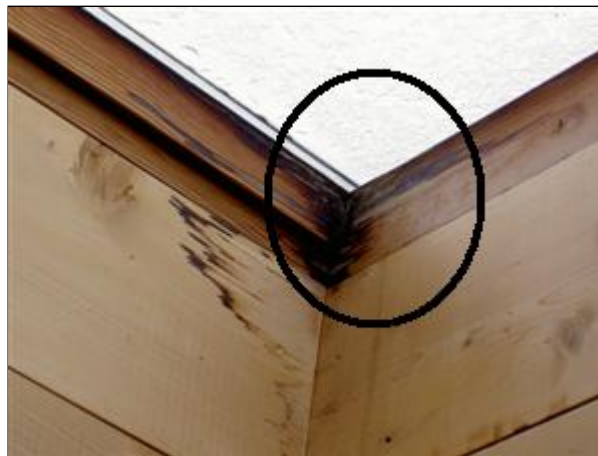
( Picture 1) The skylights in the sunroom, and room attached to the sunroom, show signs of water intrusion and damage. It was not raining at the time of inspection so it was not possible to determine if the wood damage was caused by window moisture, condensation, or active leaks. The skylight window frame should be repaired and treated, as required, to prevent further deterioration. Any active leaks should be repaired, as required.

1.2 Picture 1 rotted wood

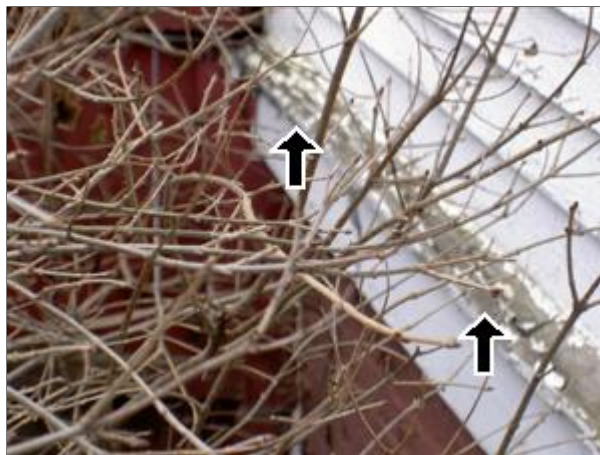
(Picture1)(Picture 3) The decorative trim around the home, has several areas of deteriorated wood. The deteriorated trim areas should be replaced, and all of the trim repainted, to prevent further decay. The area seen in this picture, is especially bad, because the shrub is too close to the home, not

2.0 Picture 1 Deteriorated siding trim

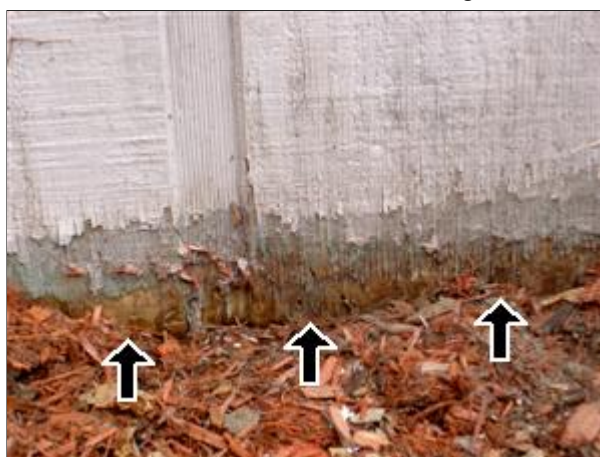
allowing the siding or trim to fully dry. (Picture 2) The T-111 siding on the sunroom, is in contact with the ground, and has deteriorated from water contact. (Picture 4)(Picture 5) Wood siding should not be in contact with the ground. I recommend removing soil from this area, and repair or replace the affected siding. The situation observed in the picture, is a perfect avenue for termites to enter the structure.

2.0 Picture 2 Siding deteriorated

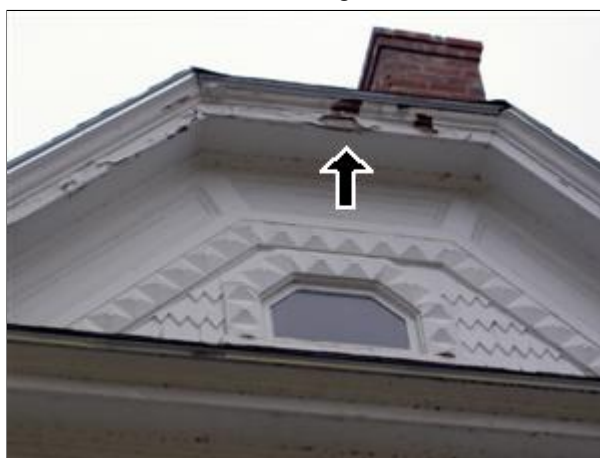
2.0 Picture 3 Exterior trim needs paint

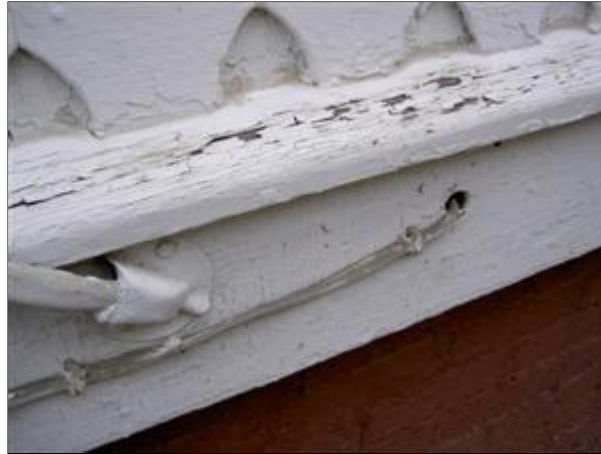
2.0 Picture 4 open holes

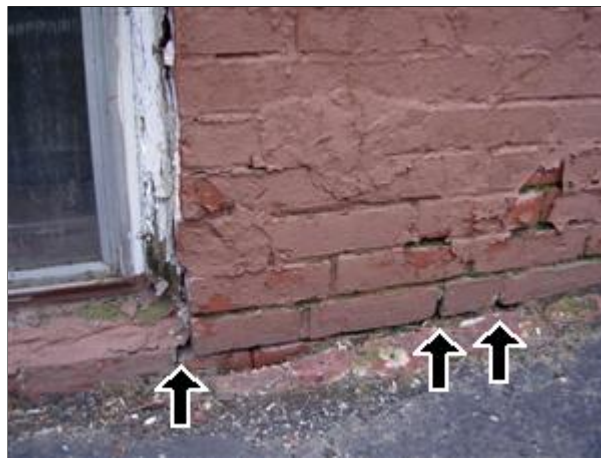
( Picture 5 ) There are several areas around the brick foundation where the mortar has deteriorated. I recommend these areas be repaired (re-pointed) as soon as possible to prevent further damage. This type of damage is typically cause by large volumes of water running off the roof onto the ground and splashing back onto the brick. Without gutters these areas need constant attention

2.0 Picture 5 brick mortar deteriorated

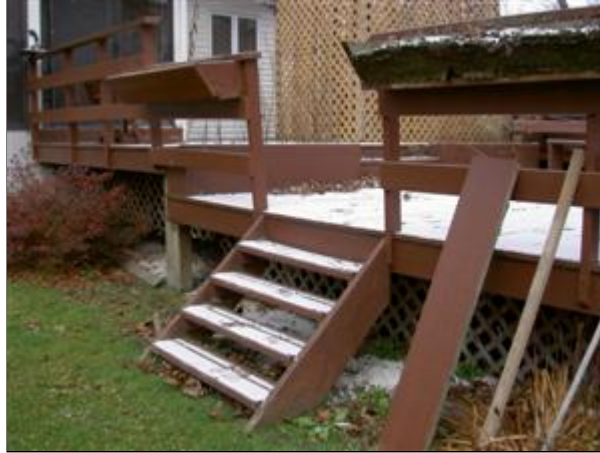
(Picture1) The deck steps should have a handrail installed. (Picture 2) Front porch settling. (Picture 3) Rear porch settling. The porches have settled allowing the roof to pull away from the home, about an inch. At this time the situation does not appear severe. The porches should be monitored, and addressed, if further settling occurs. (Picture 4) The front steps have sunk into the ground, causing a pitch of the step from front to back. This condition could allow water to pool and freeze, which could cause a slip hazard.

2.3 Picture 1 deck without handrail

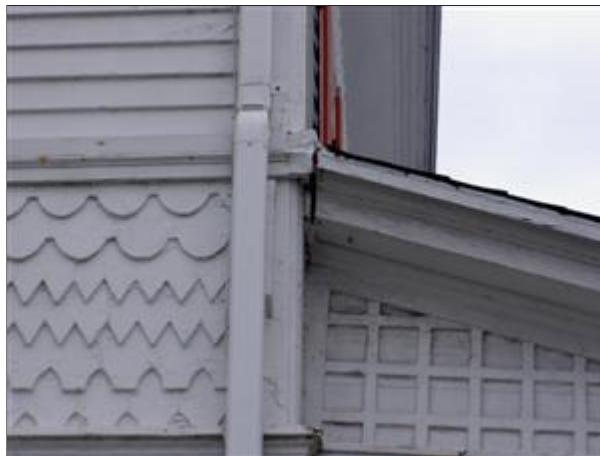
2.3 Picture 2 front porch settling

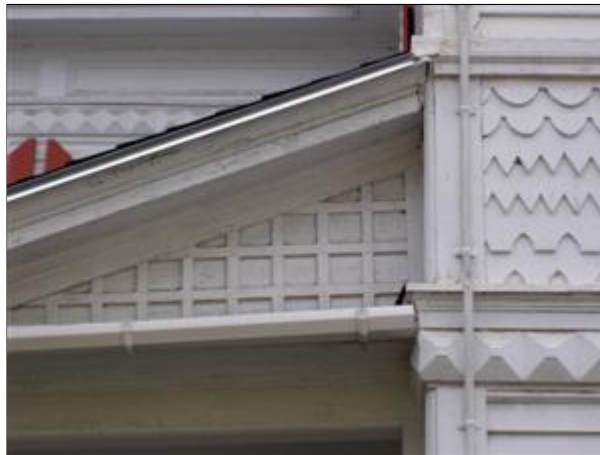
2.3 Picture 3 rear porch settling

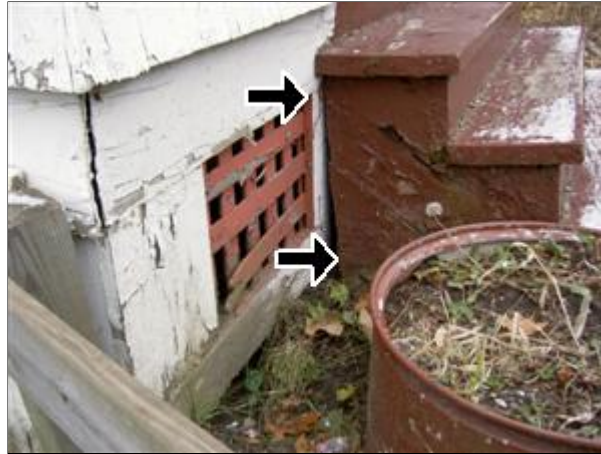
2.3 Picture 4 front step sagging

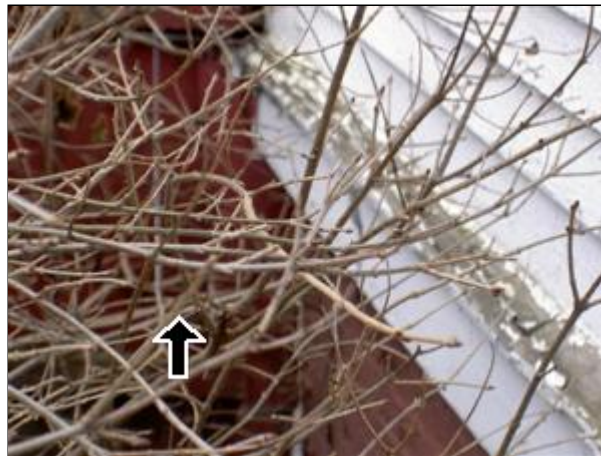
(Picture1) Trees and bushes too close to the home, will inhibit the siding from drying. Constantly damp, improperly treated wood, is a formula for rot and mold. Trees and shrubs should be keep at least three feet away from the exterior of the home.

2.4 Picture 1 shrubs too close to home

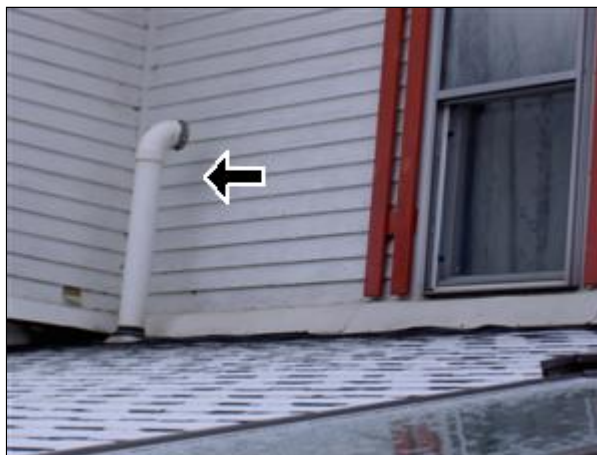
The laundry room dryer vent, appears to have not been connected properly, due to the excessive amount of lint in the basement. All clothes dryer vents, should be of either solid metal pipe, or approved flexible, metal pipe, vented to the outside of the home. I recommend replacement of the existing dryer vent system. (Picture 1) The owner's representative, stated this photo may be the dryer vent. If this is the dryer vent, I believe the length and height of the vent could pose a problem with proper venting, and the possibility of lint filling the low area of the vent stack. I recommend the installation of an approved, metal dryer vent, with the shortest exit from the home.

4.15 Picture 1 dryer vent pipe too long

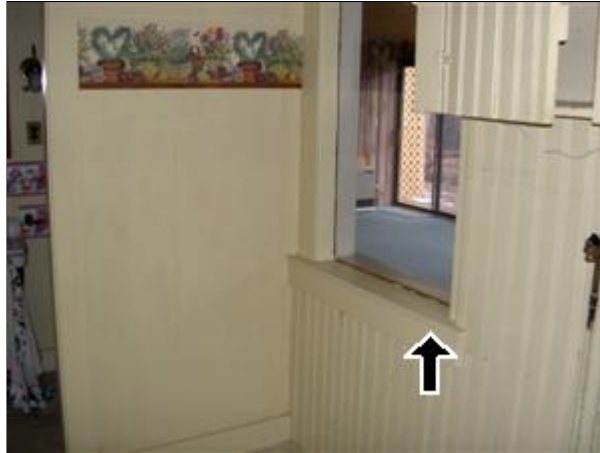
(Picture 1) The window between the laundry room and the new sunroom, is not safety glass. Because of the location of this window, the possibility exists that a person could lean against the window, and break the glass, which could cause personal injury. I recommend replacing it with safety glass. The home has some new, and some original, older windows. A sampling of the windows was done. The windows inspected were in serviceable condition.

5.5 Picture 1 window not safety glass

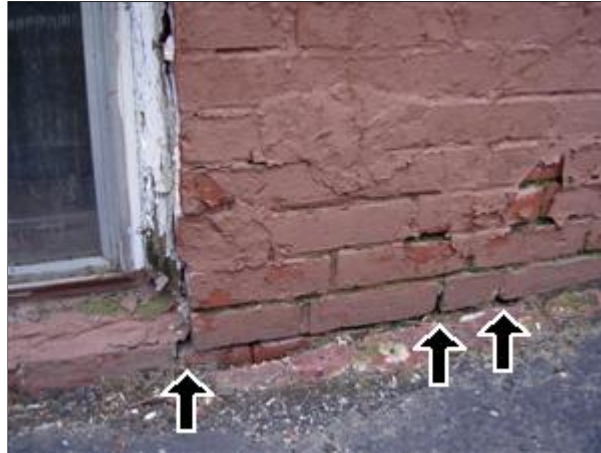
🏠 The home's foundation is brick-on-stone. (Picture 1) The brick on the outside of the foundation is experiencing mortar decay. This is caused from water running off the roof and splashing back onto the brick. Re-pointing of the brick is recommended to limit the further deterioration. (Picture 2) The cellar wall, at the exit of the hatchway, appears to be bowing inward, towards the cellar, on both sides of the hatchway. The hatchway appears to have been added in recent years, by cutting a section of the foundation. I recommend having a structural engineer evaluate this area. (Picture 3) The white substance on the wall in this picture, is called white effervescence, which is caused by a constant cycle of water or wetness, and drying. There is also a chance, the presence of the water in the winter could freeze, causing the wall to move inward.

8.0 Picture 1 brick mortar decay

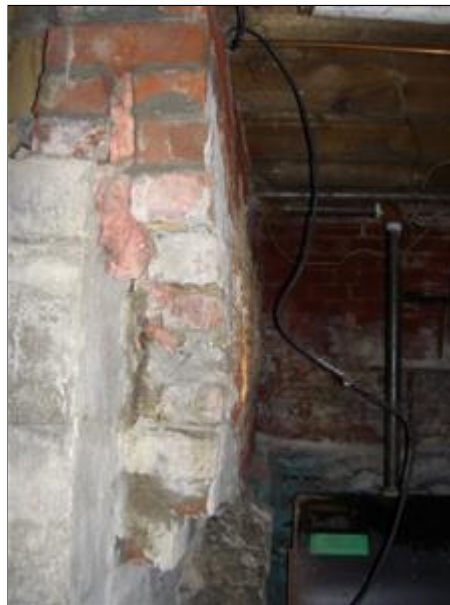
8.0 Picture 2 possible bow in cellar wall

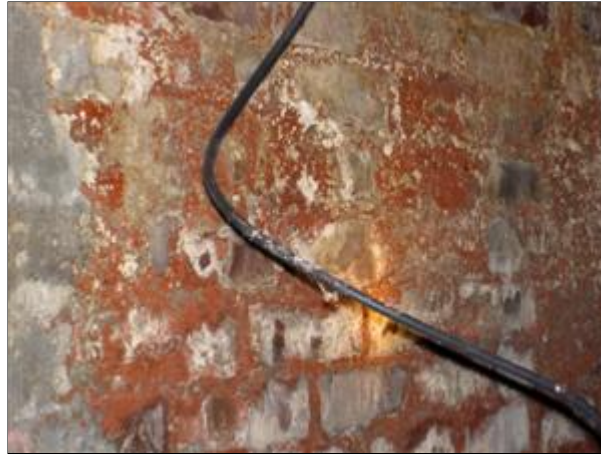
8.0 Picture 3 white effervescence on cellar wall

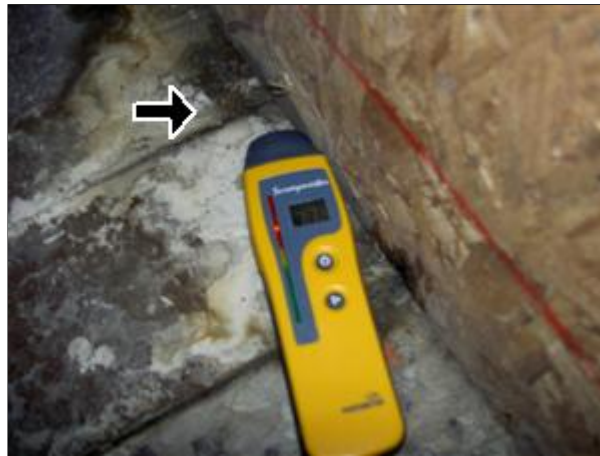
The cellar stairs have a marginal tread run. This means the tread top area, is very short. Caution should be observed when entering the cellar, using these stairs. (Picture1) The bottom step of the cellar stairs, shows signs of excessive moisture, as viewed and tested with a moisture meter device. This area should be treated and monitored, to reduce the possibility of the step deteriorating.

8.7 Picture 1 excessive moisture

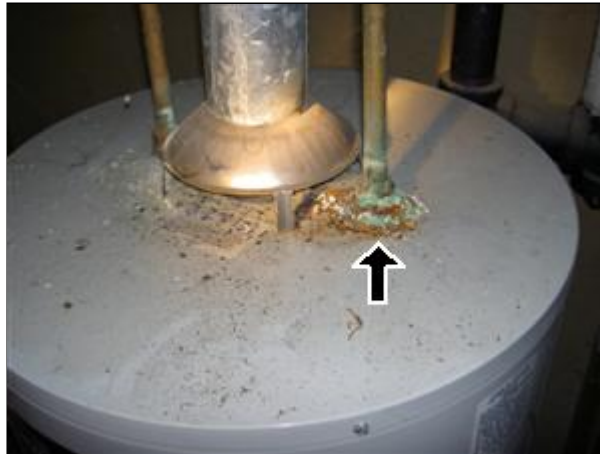
(Picture1) There is excessive corrosion, at the cold water pipe entrance, to the hot water heater. This is a 40 gallon, gas fired, hot water system, normally designed for two-person consumption. The water heater could be nearing the end of its useful life.

9.2 Picture 1 corrosion at the cold water inlet

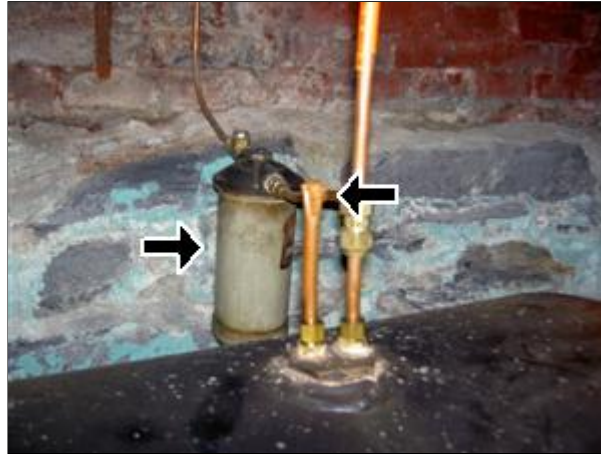
(Picture1) One, unused oil tank outlet line, has been crimped to terminate it. The proper way to terminate any unused oil lines, is to install a proper, tight fitting cap. I recommend the installation of a correct cap. There is no installed oil filter, from the oil tank to the oil burner. The filter seen in photo has been disconnected. A filter is recommended to inhibit the entrance of foreign material and water, from entering the burner, which could affect or inhibit proper operation. (Picture 2) There is an exposed pipe coming into the basement, approximately twelve feet to the right, of the oil tank. I am uncertain what this pipe was used for. I recommend checking with the previous owners to see if there was, or is, a buried oil storage tank.

9.4 Picture 1 crimped oil tank outlet line

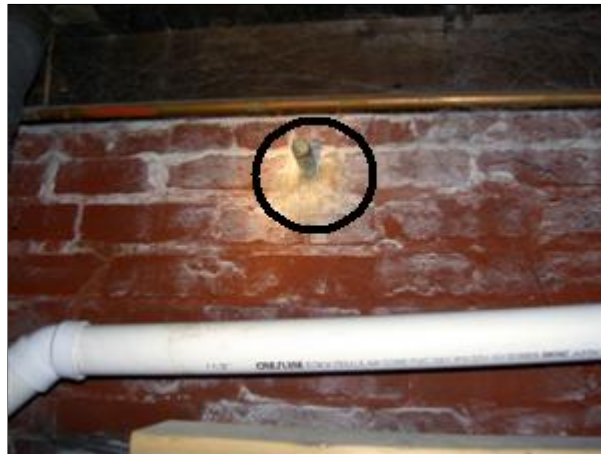
9.4 Picture 2 exposed pipe in the basement

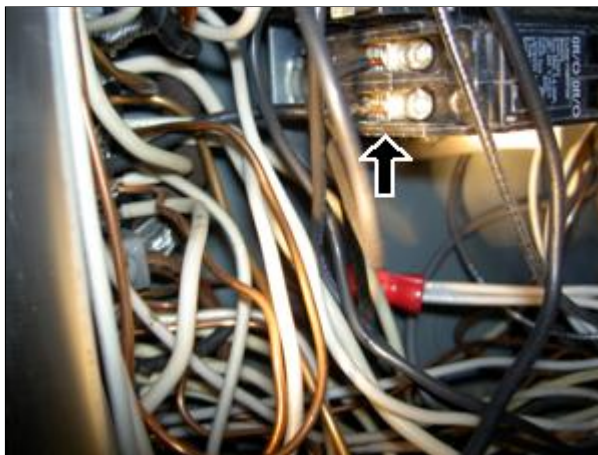
10.2 Picture 1 double tapped circuit breaker

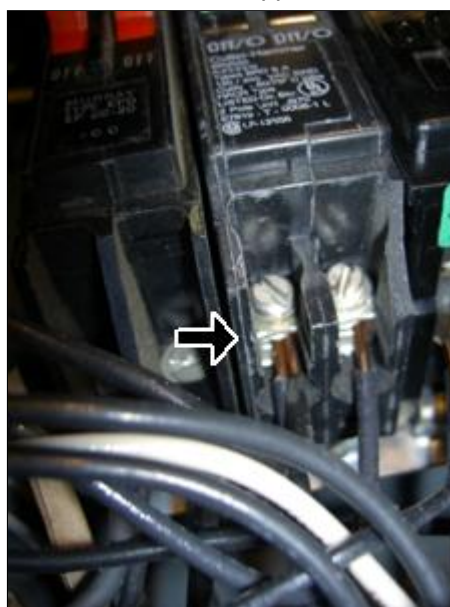
10.2 Picture 2 double tapped circuit breaker

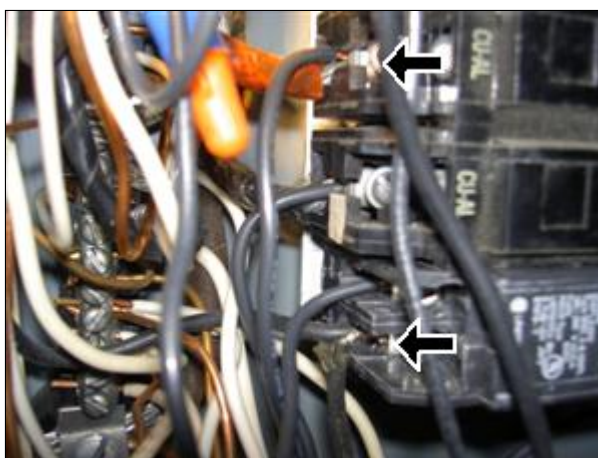
10.2 Picture 3 double tapped circuit breaker

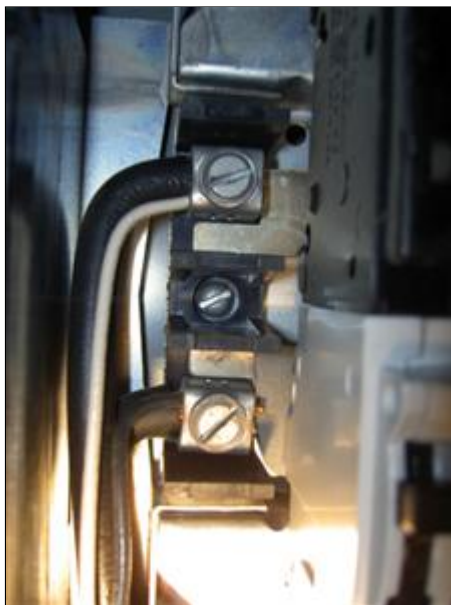
10.2 Picture 4 dryer tapped power

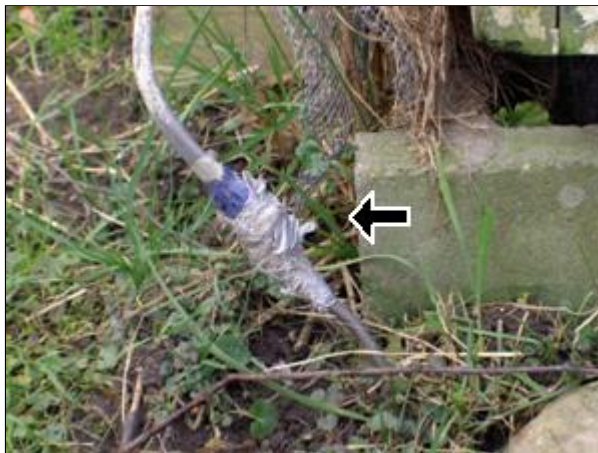
10.2 Picture 5 wire splice at garage

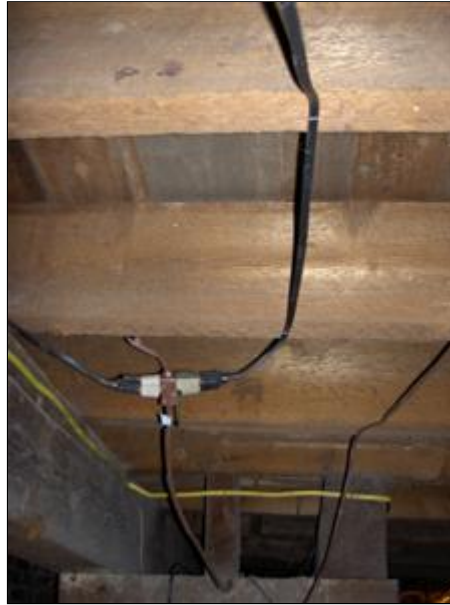
(Picture1) Extension cord in the basement, being use to power the overhead lights, is fastened to the floor joist, by bare metal staples. The staples could cut into the cord causing a short or possibly a fire. This cord should be removed, and a proper Romex-type conductor installed.

10.3 Picture 1 extension cord

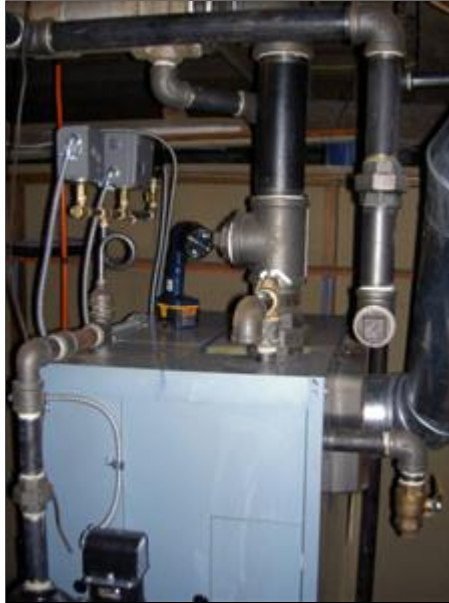
(Picture1) The heating system was reported to be new, by the owners representative. The HB Smith Heating System appeared to be new and in good working order.

11.0 Picture 1 HB Smith boiler

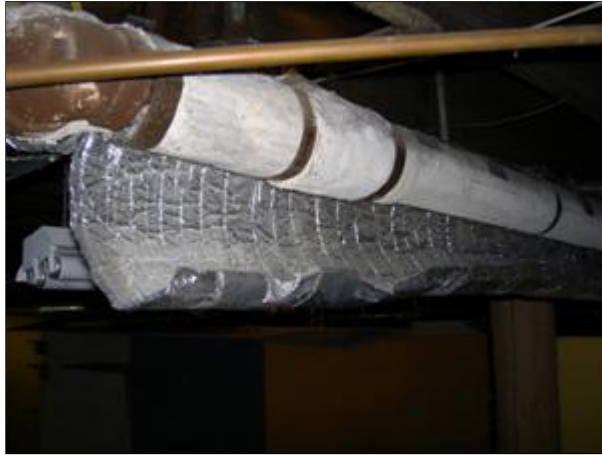
(Picture1) The steam pipes in the basement are covered with an asbestos-like material. I recommend you do some research about the presence of asbestos material in a home. The EPA web site has a host of information, regarding asbestos.

11.3 Picture 1 asbestos-like material

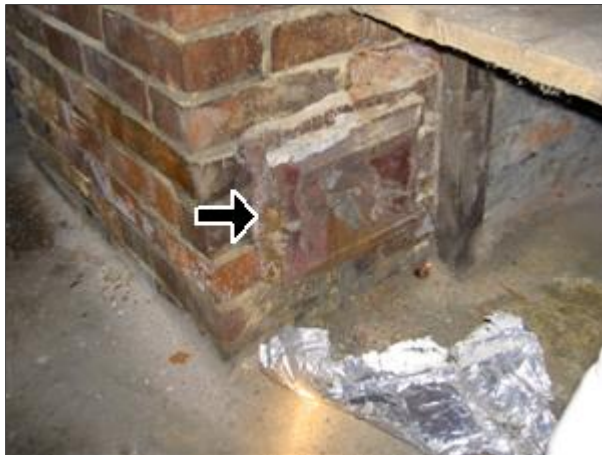
(Picture1) The fuel clean out door, is completely corroded. The flue appears to be full of debris. I recommend having the chimney cleaned and inspected by a qualified chimney sweep. The top cap of the chimney, on the east side of the home, shows some deterioration of mortar between the bricks. A qualified mason should be contacted, for a professional inspection of this area.

11.5 Picture 1 flue clean out door

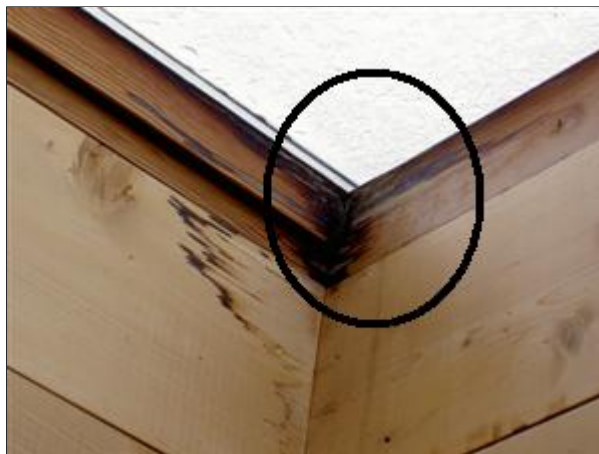
1. ( Picture 1) The skylights in the sunroom, and room attached to the sunroom, show signs of water intrusion and damage. It was not raining at the time of inspection so it was not possible to determine if the wood damage was caused by window moisture, condensation, or active leaks. The skylight window frame should be repaired and treated, as required, to prevent further deterioration. Any active leaks should be repaired, as required.

Item 1 - Picture 1 rotted wood

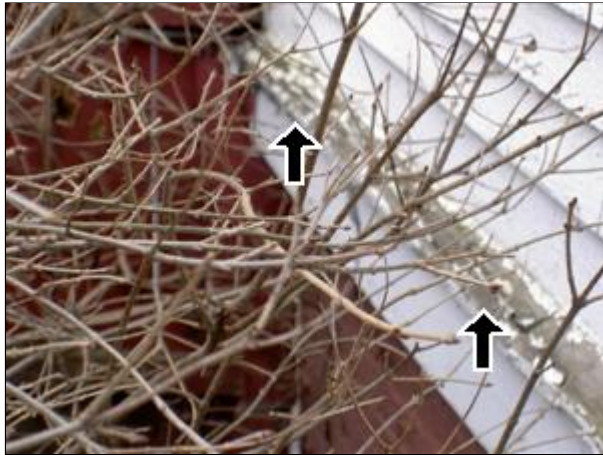
Item 2 - Picture 1 Deteriorated siding trim

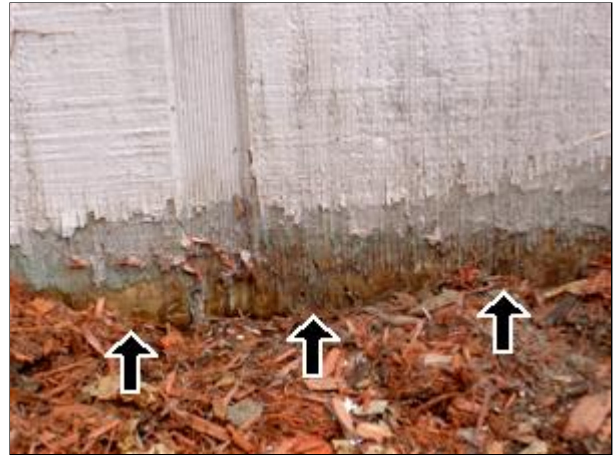
Item 2 - Picture 2 Siding deteriorated

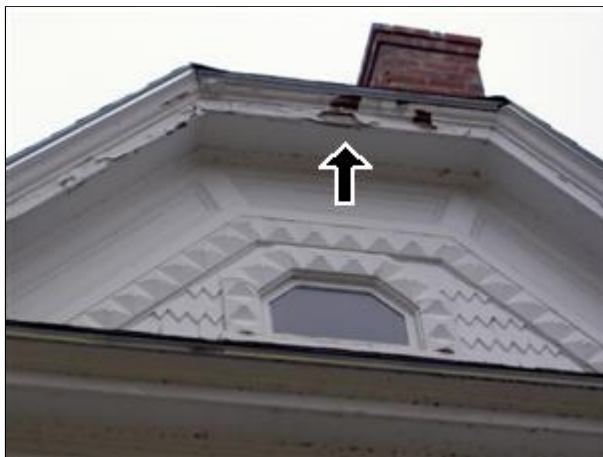
Item 2 - Picture 3 Exterior trim needs paint

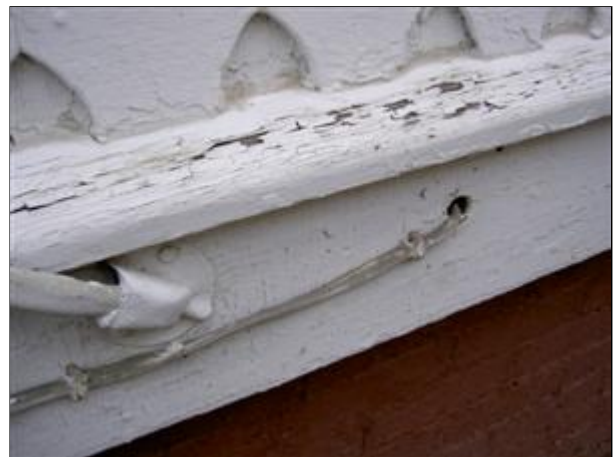
Item 2 - Picture 4 open holes

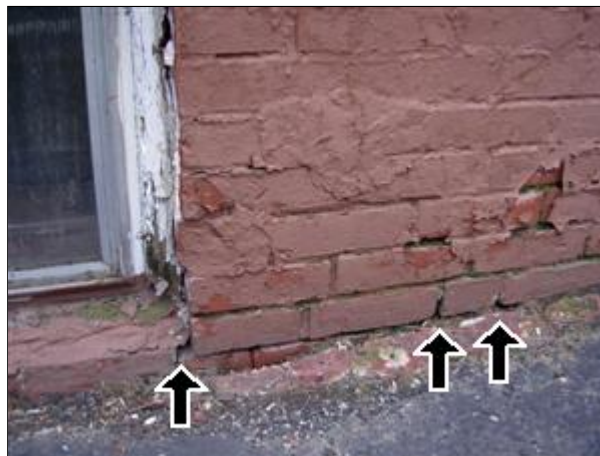
Item 2 - Picture 5 brick mortar deteriorated

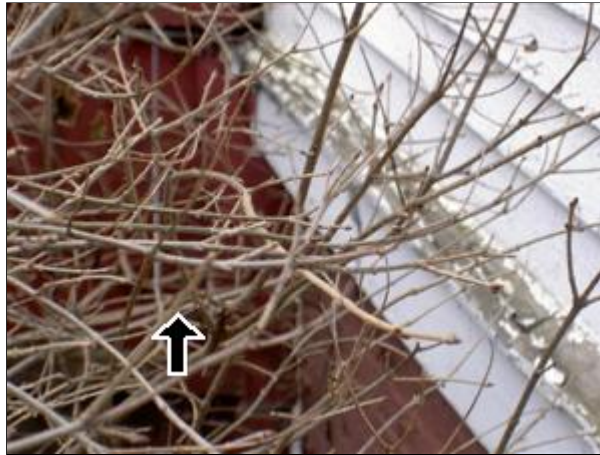
- 3. (Picture1) Trees and bushes too close to the home, will inhibit the siding from drying. Constantly damp, improperly treated wood, is a formula for rot and mold. Trees and shrubs should be keep at least three feet away from the exterior of the home.

Item 3 - Picture 1 shrubs too close to home

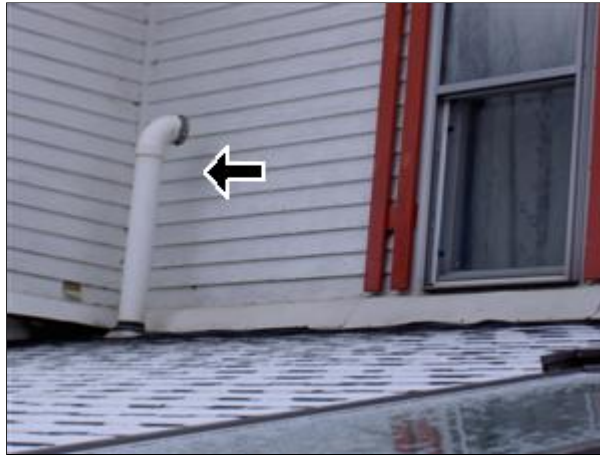
7. The laundry room dryer vent, appears to have not been connected properly, due to the excessive amount of lint in the basement. All clothes dryer vents, should be of either solid metal pipe, or approved flexible, metal pipe, vented to the outside of the home. I recommend replacement of the existing dryer vent system. (Picture 1) The owner's representative, stated this photo may be the dryer vent. If this is the dryer vent, I believe the length and height of the vent could pose a problem with proper venting, and the possibility of lint filling the low area of the vent stack. I recommend the installation of an approved, metal dryer vent, with the shortest exit from the home.

Item 7 - Picture 1 dryer vent pipe too long

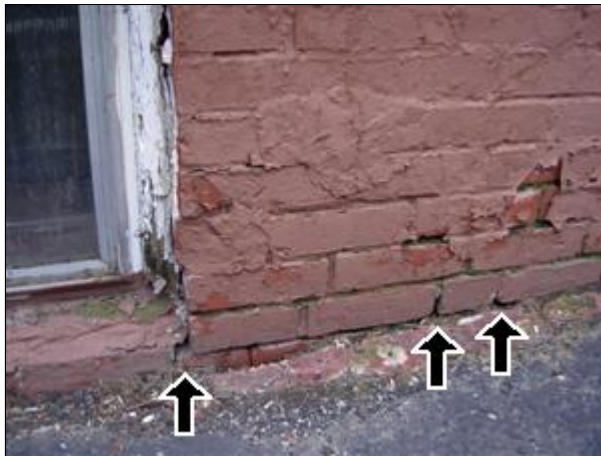
16. The home's foundation is brick-on-stone. (Picture 1) The brick on the outside of the foundation is experiencing mortar decay. This is caused from water running off the roof and splashing back onto the brick. Re-pointing of the brick is recommended to limit the further deterioration. (Picture 2) The cellar wall, at the exit of the hatchway, appears to be bowing inward, towards the cellar, on both sides of the hatchway. The hatchway appears to have been added in recent years, by cutting a section of the foundation. I recommend having a structural engineer evaluate this area. (Picture 3) The white substance on the wall in this picture, is called white effervescence, which is caused by a constant cycle of water or wetness, and drying. There is also a chance, the presence of the water in the winter could freeze, causing the wall to move inward.

Item 16 - Picture 1 brick mortar decay

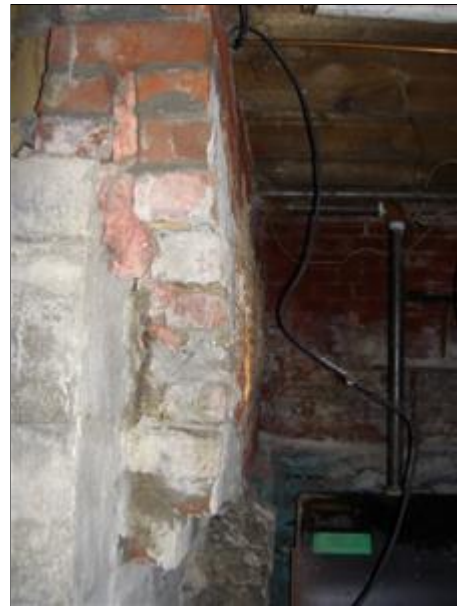
Item 16 - Picture 2 possible bow in cellar wall

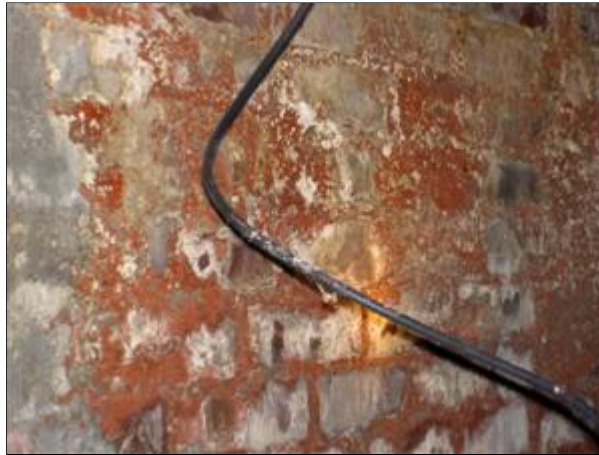
Item 16 - Picture 3 white effervescence on cellar wall

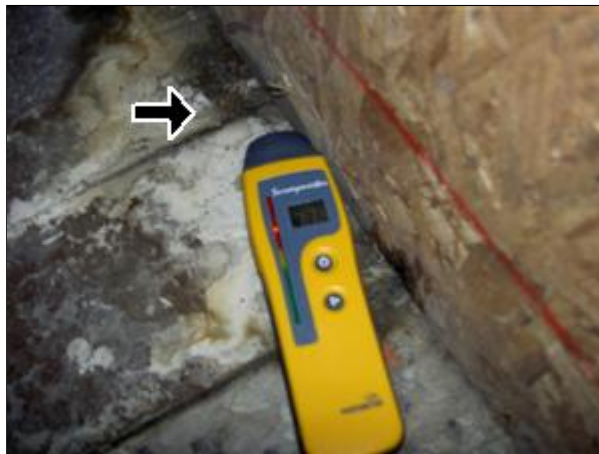
17. The cellar stairs have a marginal tread run. This means the tread top area, is very short. Caution should be observed when entering the cellar, using these stairs. (Picture1) The bottom step of the cellar stairs, shows signs of excessive moisture, as viewed and tested with a moisture meter device. This area should be treated and monitored, to reduce the possibility of the step deteriorating.

Item 17 - Picture 1 excessive moisture

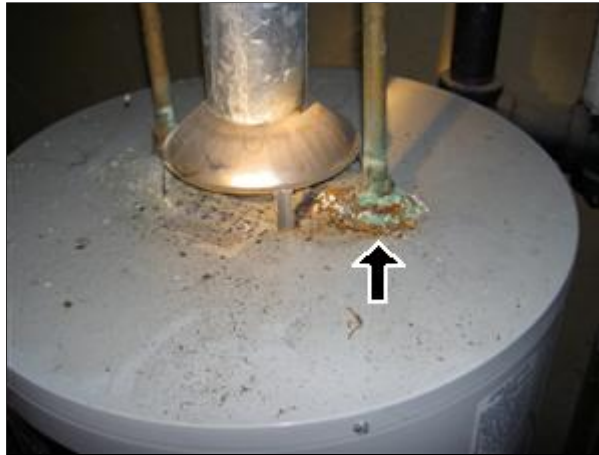
19. (Picture1) There is excessive corrosion, at the cold water pipe entrance, to the hot water heater. This is a 40 gallon, gas fired, hot water system, normally designed for two-person consumption. The water heater could be nearing the end of its useful life.

Item 19 - Picture 1 corrosion at the cold water inlet

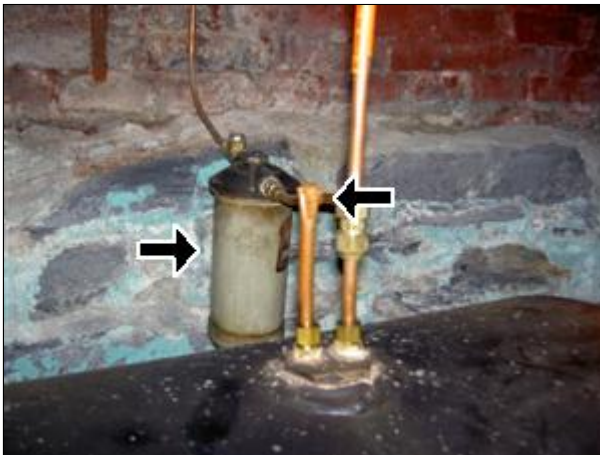
20. (Picture 1) One, unused oil tank outlet line, has been crimped to terminate it. The proper way to terminate any unused oil lines, is to install a proper, tight fitting cap. I recommend the installation of a correct cap. There is no installed oil filter, from the oil tank to the oil burner. The filter seen in photo has been disconnected. A filter is recommended to inhibit the entrance of foreign material and water, from entering the burner, which could affect or inhibit proper operation. (Picture 2) There is an exposed pipe coming into the basement, approximately twelve feet to the right, of the oil tank. I am uncertain what this pipe was used for. I recommend checking with the previous owners to see if there was, or is, a buried oil storage tank.

Item 20 - Picture 1 crimped oil tank outlet line

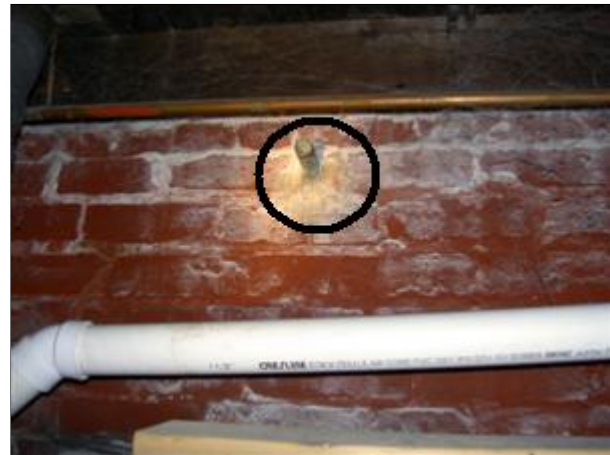
Item 20 - Picture 2 exposed pipe in the basement

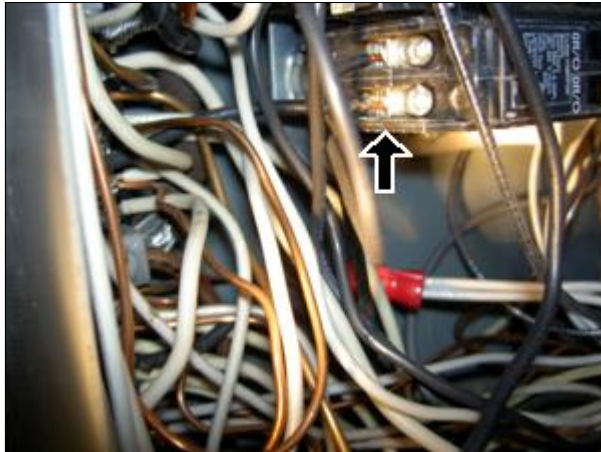
Item 21 - Picture 1 double tapped circuit breaker

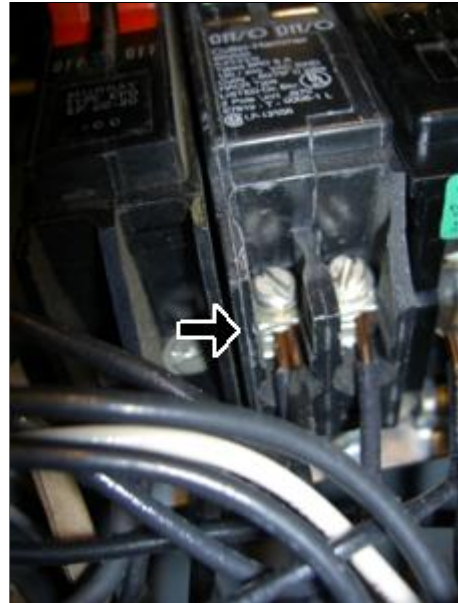
Item 21 - Picture 2 double tapped circuit breaker

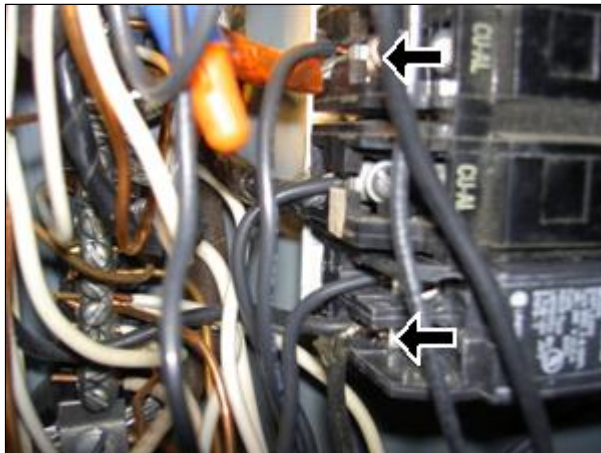
Item 21 - Picture 3 double tapped circuit breaker

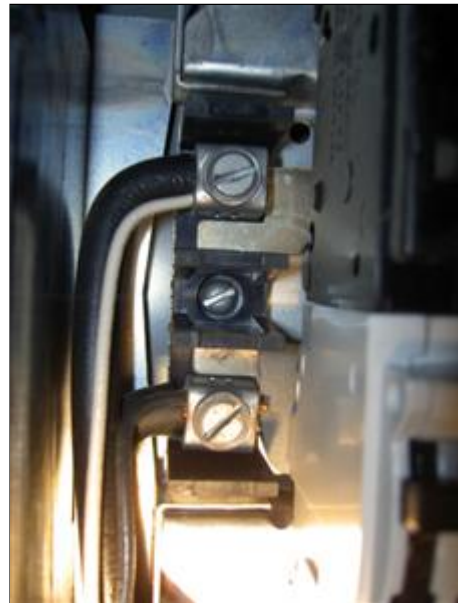
Item 21 - Picture 4 dryer tapped power

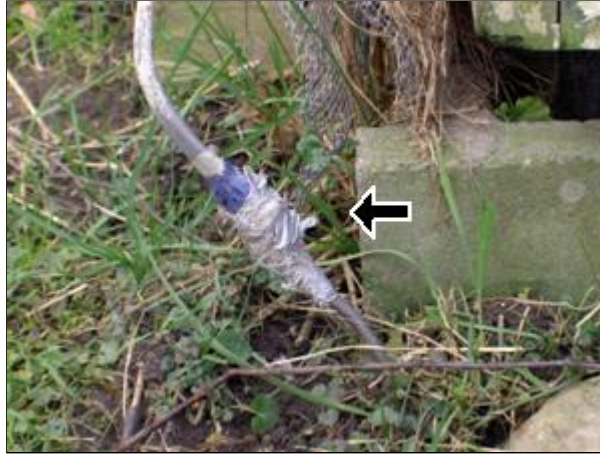
Item 21 - Picture 5 wire splice at garage

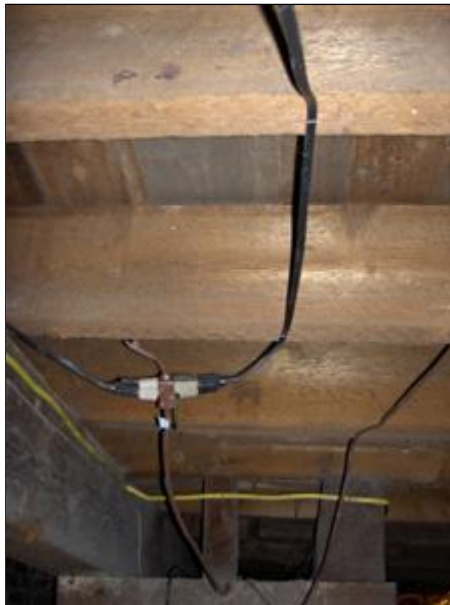
**22.** (Picture1) Extension cord in the basement, being use to power the overhead lights, is fastened to the floor joist, by bare metal staples. The staples could cut into the cord causing a short or possibly a fire. This cord should be removed, and a proper Romex-type conductor installed.

Item 22 - Picture 1 extension cord

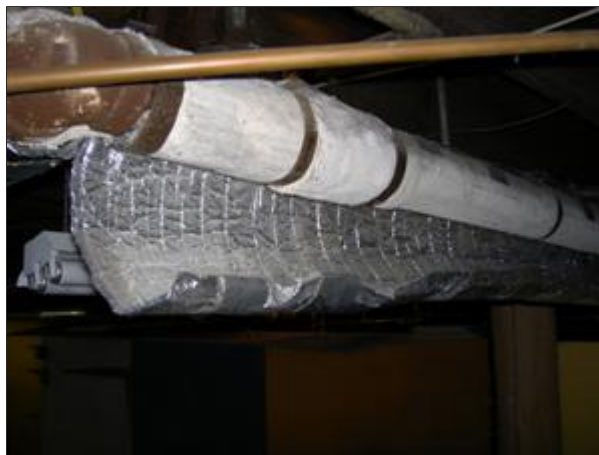
26. (Picture1) The steam pipes in the basement are covered with an asbestos-like material. I recommend you do some research about the presence of asbestos material in a home. The EPA web site has a host of information, regarding asbestos.

Item 26 - Picture 1 asbestos-like material

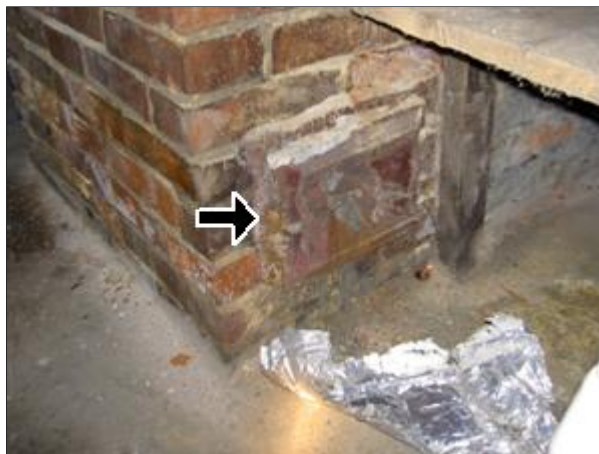
Item 27 - Picture 1 flue clean out door
